Volume 4, Number 2  
Summer 2008  
Feature

## For its Rotorcraft, Navy is Switching to Aluminum Gearboxes

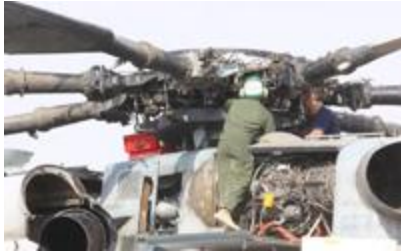
A U.S. Marine, left, and a civilian contractor with Marine Heavy Helicopter Squadron 465, work on the gearbox of an H-53 helicopter in Al Asad, Iraq, in the fall of 2006. Photo by Cpl. Richard A. Hilario, U.S. Marine Corps.
